# Manhole Inspection Summary

Manhole # S33GG\_003MH

**Location** Address: **128 MARYLAND AVE**

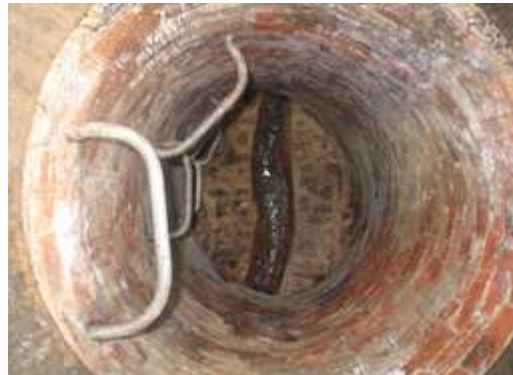
Top View

Bench debris.

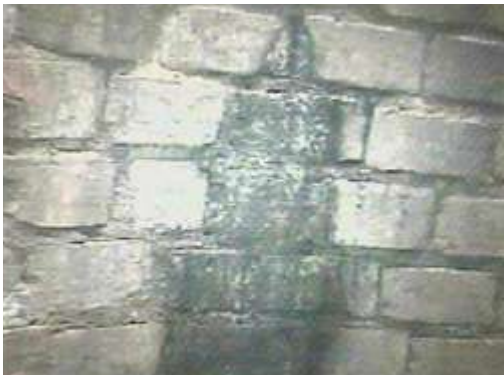
Defect

Infiltration: ☐ None ☐ Joint ☐ Cracks ☒ **Mortar** ☐ Roots ☒ **Wall**

Barrel infiltration.

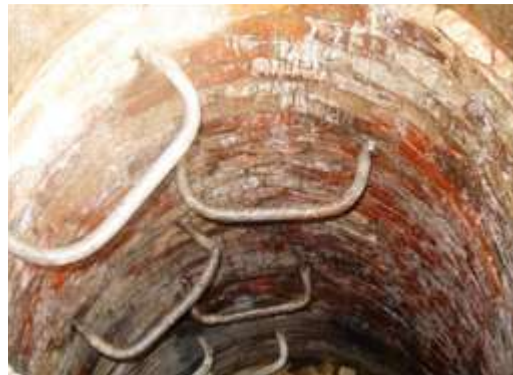
Defect

Condition: ☐ Sound ☐ Cracked ☐ Root Intrusion ☐ Loose Brick ☒ **Deteriorated**

Infiltration: ☐ None ☒ **Joint** ☐ Cracks ☒ **Mortar** ☐ Roots ☐ Wall

Infiltration: ☐ None ☐ Joint ☐ Cracks ☒ **Mortar** ☐ Roots ☒ **Wall**

Adjustment deterioration and infiltration.  
Corbel and Barrel infiltration.

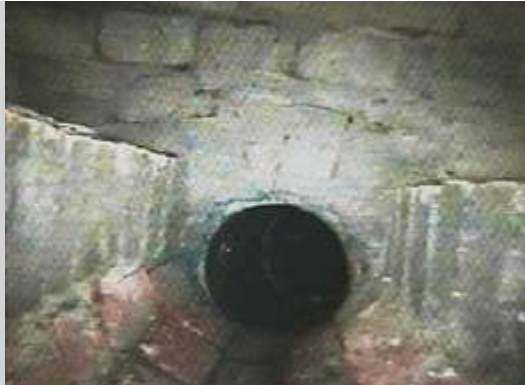
### 6 in. Circular Gravity Sewer Pipe Out @ 12 O'Clock

Barrel deterioration and infiltration. Channel deterioration.

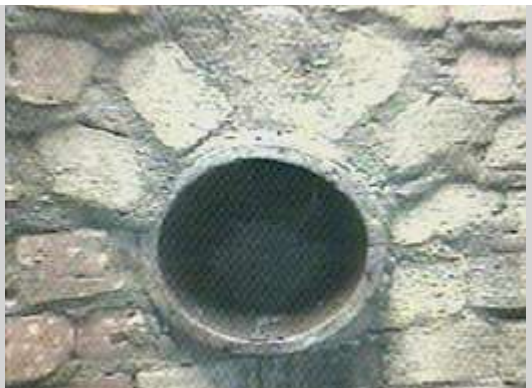
### 8 in. Circular Gravity Sewer Pipe In @ 7 O'Clock

Infiltration: **Evidence**

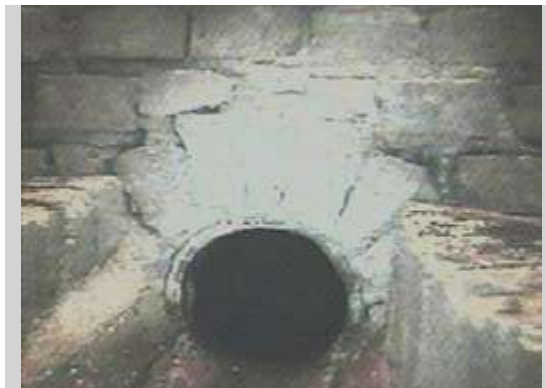
### Drop In @ 7 O'Clock

Barrel deterioration and infiltration. Channel deterioration.
